JTB00566

TECHNICAL BULLETIN

303-03 - Engine Cooling

Coolant Leak From The Engine Compartment

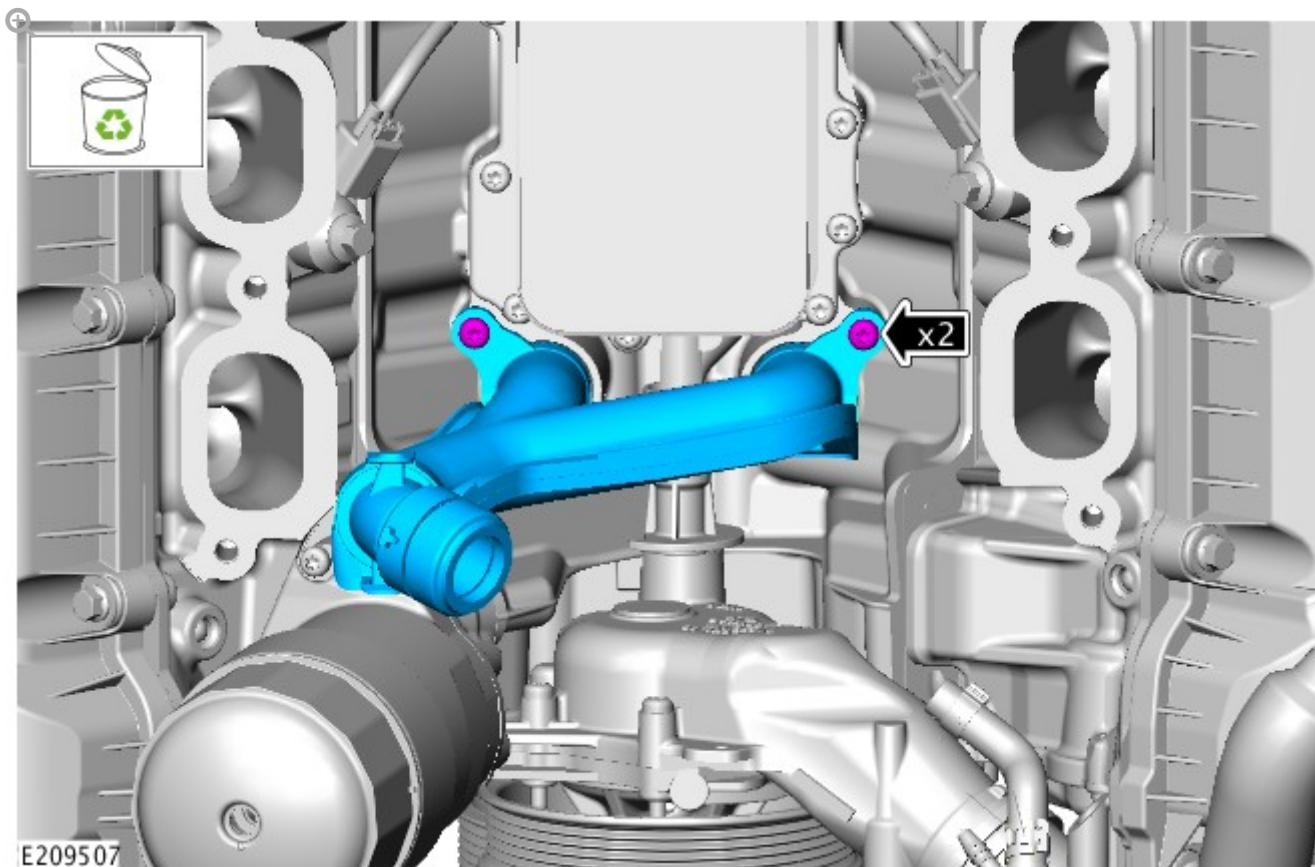
18

- Be prepared to collect escaping engine coolant.
- Make sure no part of the lower coolant return pipe remains in both cylinder block recesses as these plastic pipes can sometimes break up on removal.

Remove and discard the lower coolant outlet pipe.

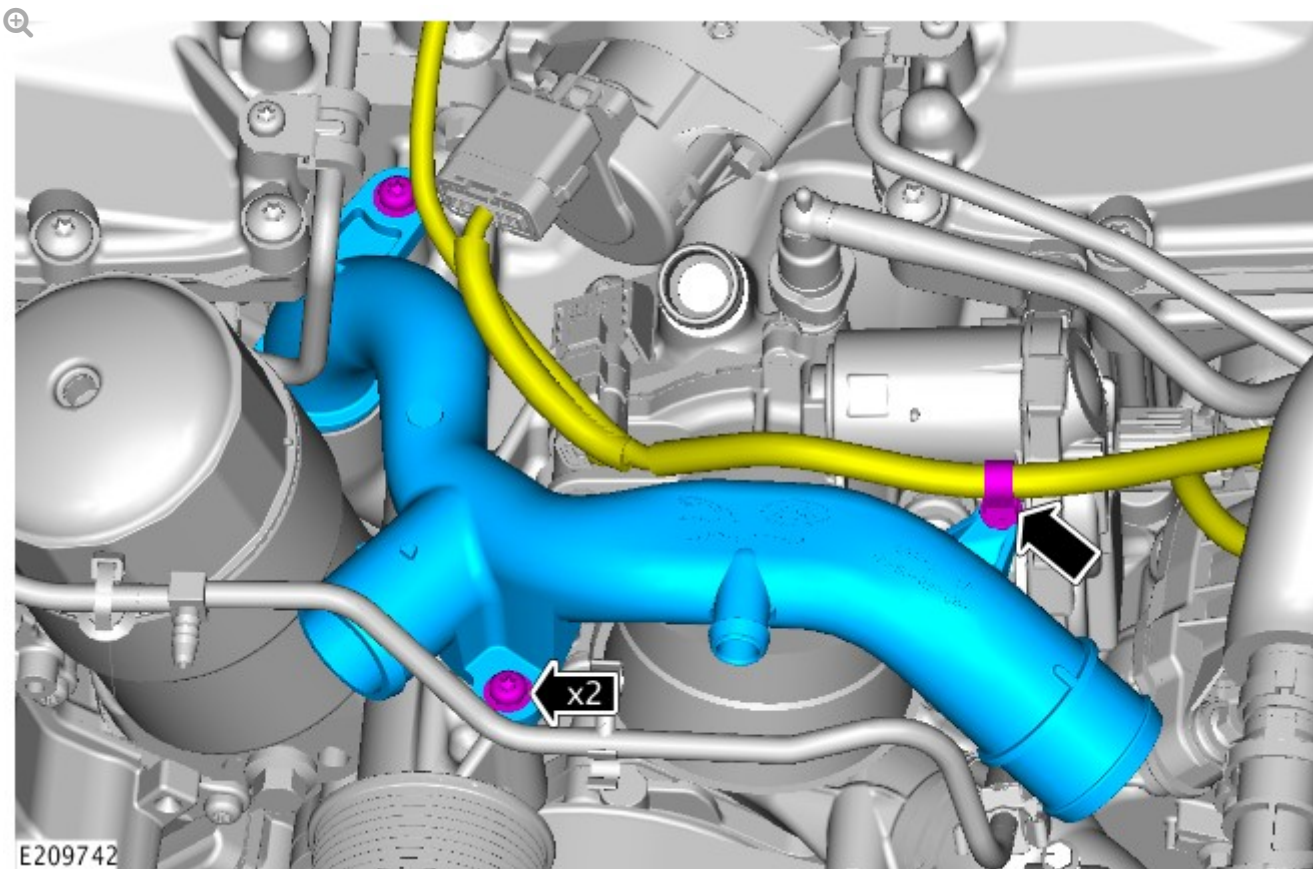
33

- Make sure to retain the fixings.
- The revised design of coolant pipe has no intermediate pipe between the upper and lower sections.

When installing the new upper coolant pipe, make sure the O-ring is correctly installed.

Install the replacement upper coolant outlet pipe.

- Clip the wiring harness to the pipe.
- **Torque: 10 Nm**
